Transport  
Canada

TP 185E  
Issue 3/2006

# AVIATION SAFETY LETTER

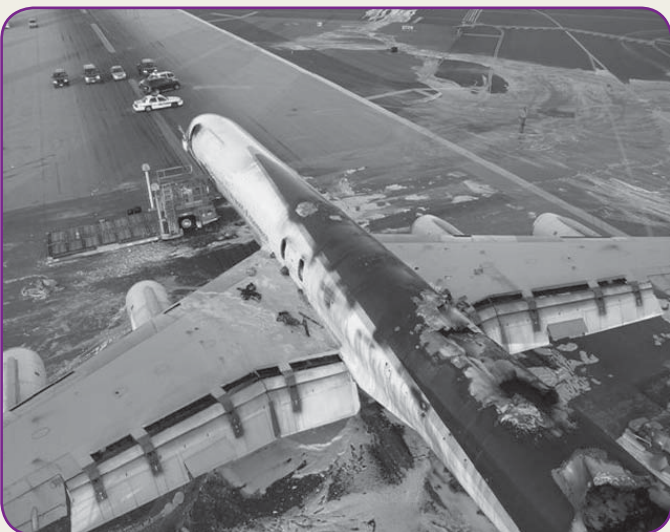
This courier flight made an emergency landing in Philadelphia, PA, after the crew detected smoke in the cockpit. The SMOKE/FIRE warning light illuminated three minutes prior to landing, and the crew asked the tower controller to confirm the presence of fire trucks, which the controller did. Upon landing, the airplane was immediately engulfed in fire and the three members of the crew evacuated the airplane via the cockpit window and a door slide. The crew was not injured; however, the airplane was destroyed. The crew did a brilliant, by-the-book job of saving their own lives, while the professional response from ATC and the firefighting units also contributed to their timely and successful egress. Two known pieces of hazardous materials (HAZMAT) were reportedly on board: amyl methyl ketone and tire repair kits. △

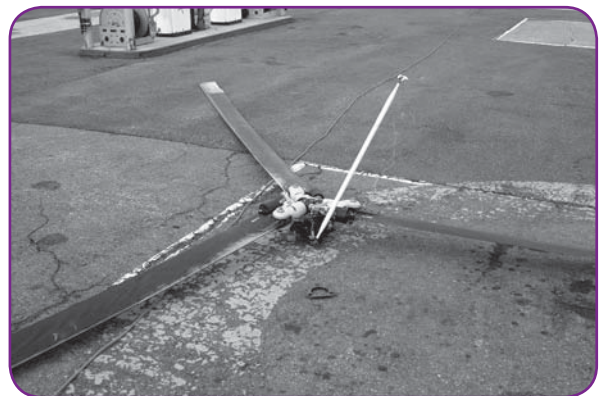
1. The input quill bearing housing was not positioned in accordance with the procedures described by the manufacturer; therefore, the flow of oil was obstructed, causing the catastrophic failure of the input quill bearings.
2. Independent inspection did not detect the incorrect reassembly of the main transmission gearbox.

Main rotor lays on the ground, after it separated from the aircraft

At the completion of the main transmission overhauls, at sudden stoppage inspections, or in any other situations in which the retainer has to be removed, the overhaul company will paint a red witness line on the retainer and on the transmission housing to assure alignment of oil ports. Also, they will run the transmission for 15 min to check that there is oil flow in the transmission, and to check for oil leaks at the seal and split line. These changes will be put into their worksheets.

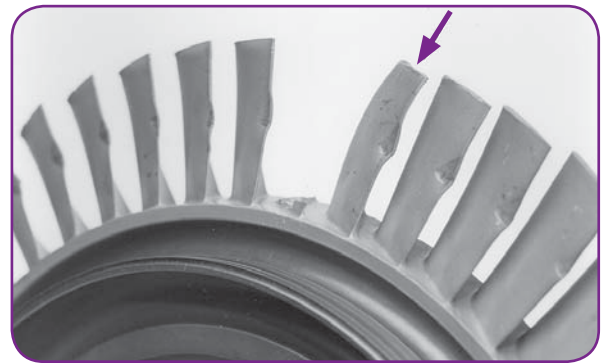
Arrow pointing to blade failure caused by thermally-induced fatigue cracking

1. Thermally-induced fatigue cracking initiated radially inward in a low-cycle mode in the blade platform fillet area, then progressed normal to the blade axis in a high-cycle mode, eventually resulting in a blade failure due to overstress rupture when the remaining area could no longer support the applied loads.

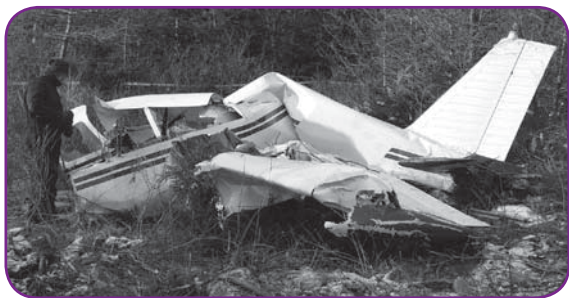
TSB aircraft accident investigator  
Allan Chaulk examines the wreckage

1. The aircraft was flying in conditions conducive to serious carburetor icing at any engine power setting. It is likely that carburetor ice formed and restricted the engine power available to the point where the aircraft would not maintain level flight.

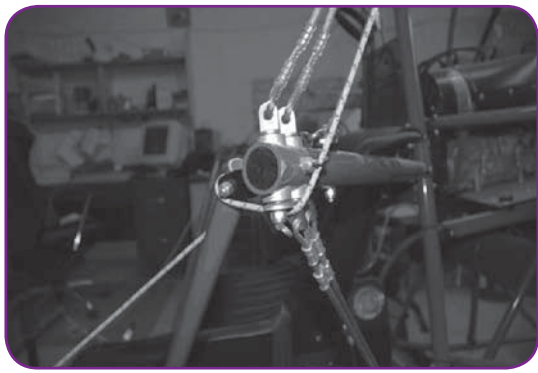
With either system, a pilot must verify that the steering lines, risers, and suspension lines are correctly positioned above the outrigger arms on the pre-flight check, by "walking the lines" with the parachute canopy and suspension lines laid out behind the cart. Standard practice also requires that the pilot apply partial power to get the cart rolling slowly at the beginning of the take-off run, and then conduct a "shoulder check" to the left and right as the parachute rises over the cart, to visually confirm that the steering lines and risers are correctly positioned above the outrigger arms. If a riser or steering line wraps around an outrigger, the wrap will effectively shorten the riser or steering line, which precludes proper chute inflation (see Figures 3 and 4).

Figure 3. Photo of the steering line wrapped around the outrigger, with the riser cables upright in the normal in-flight position

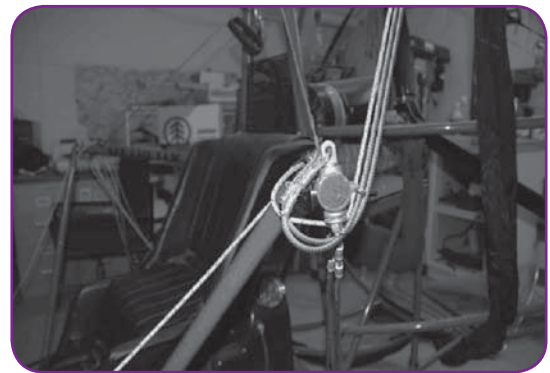
Figure 4. Photo of riser cables and steering line wrapped around the outrigger arm

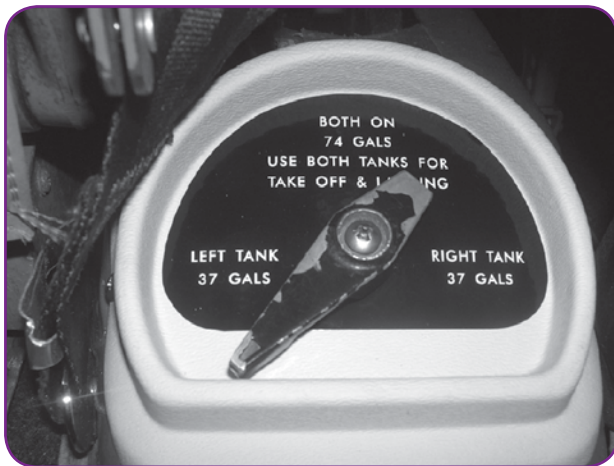
Figure 1. Fuel tank selector cover prevents selection of the undocumented OFF position

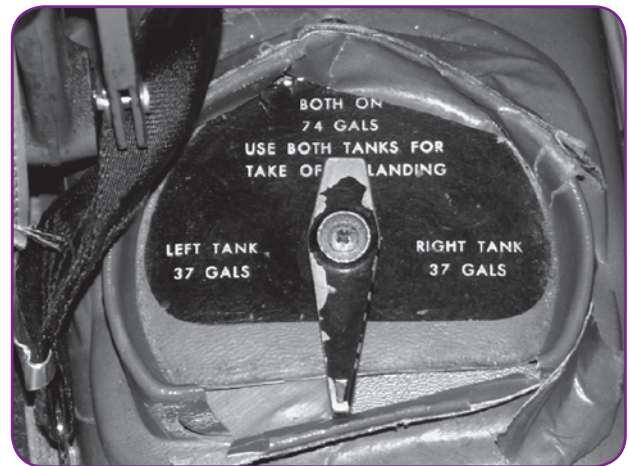
Figure 2. Damaged fuel tank selector cover—fuel selector in undocumented OFF position

As seen in Figure 2, the ridge on the plastic cover was damaged, allowing the selector valve to be rotated to the OFF position. The valve was also partially obscured by the water rudder handle, so the pilot relied on feel to determine the switch position, and the incorrect position of the valve was undetected. The fuel in the accumulator tank (approximately ½ gal.) was sufficient to allow the pilot to start the engine, taxi, carry out run-up and before-takeoff checks, and take off, before it was exhausted, shortly after the aircraft became airborne.
